APOLLO PROGRAM

FINAL FLIGHT EVALUATION REPORT APOLLO 9 MISSION

JUNE 1969

D2-117017-6
FLIGHT EVALUATION REPORT - APOLLO 9 MISSION

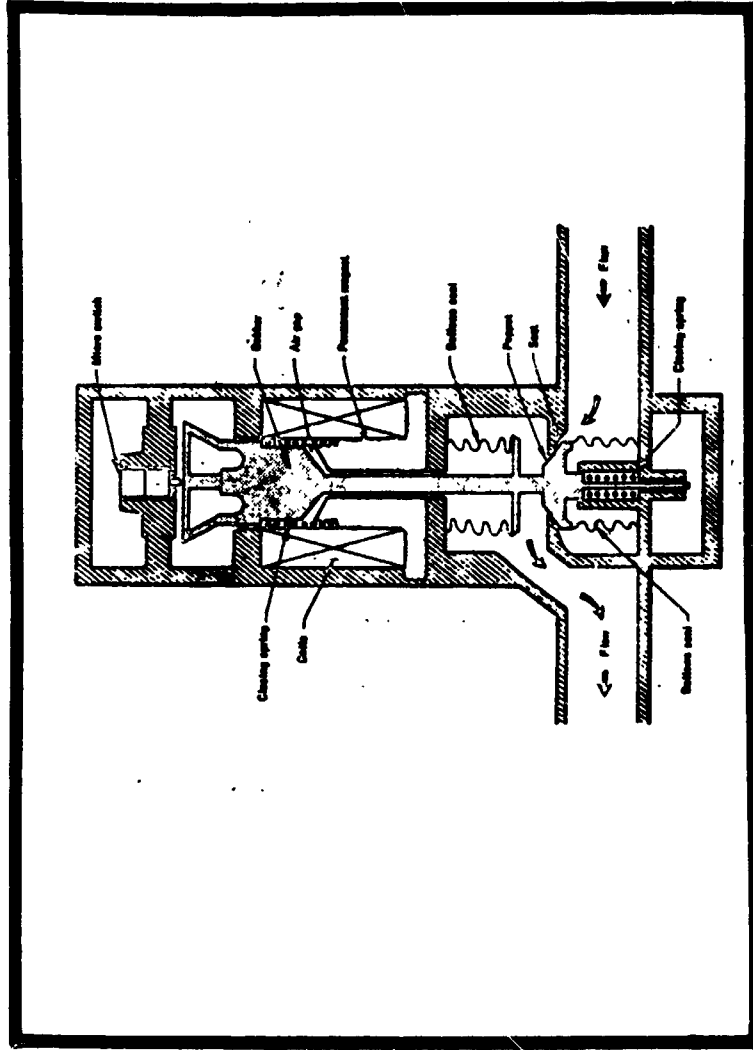
FIG. 2.1.1-1 CROSS SECTION OF REACTION CONTROL SYSTEM ISOLATION VALVE

TITLE: PROPELLANT ISOLATION VALVE CLOSURE

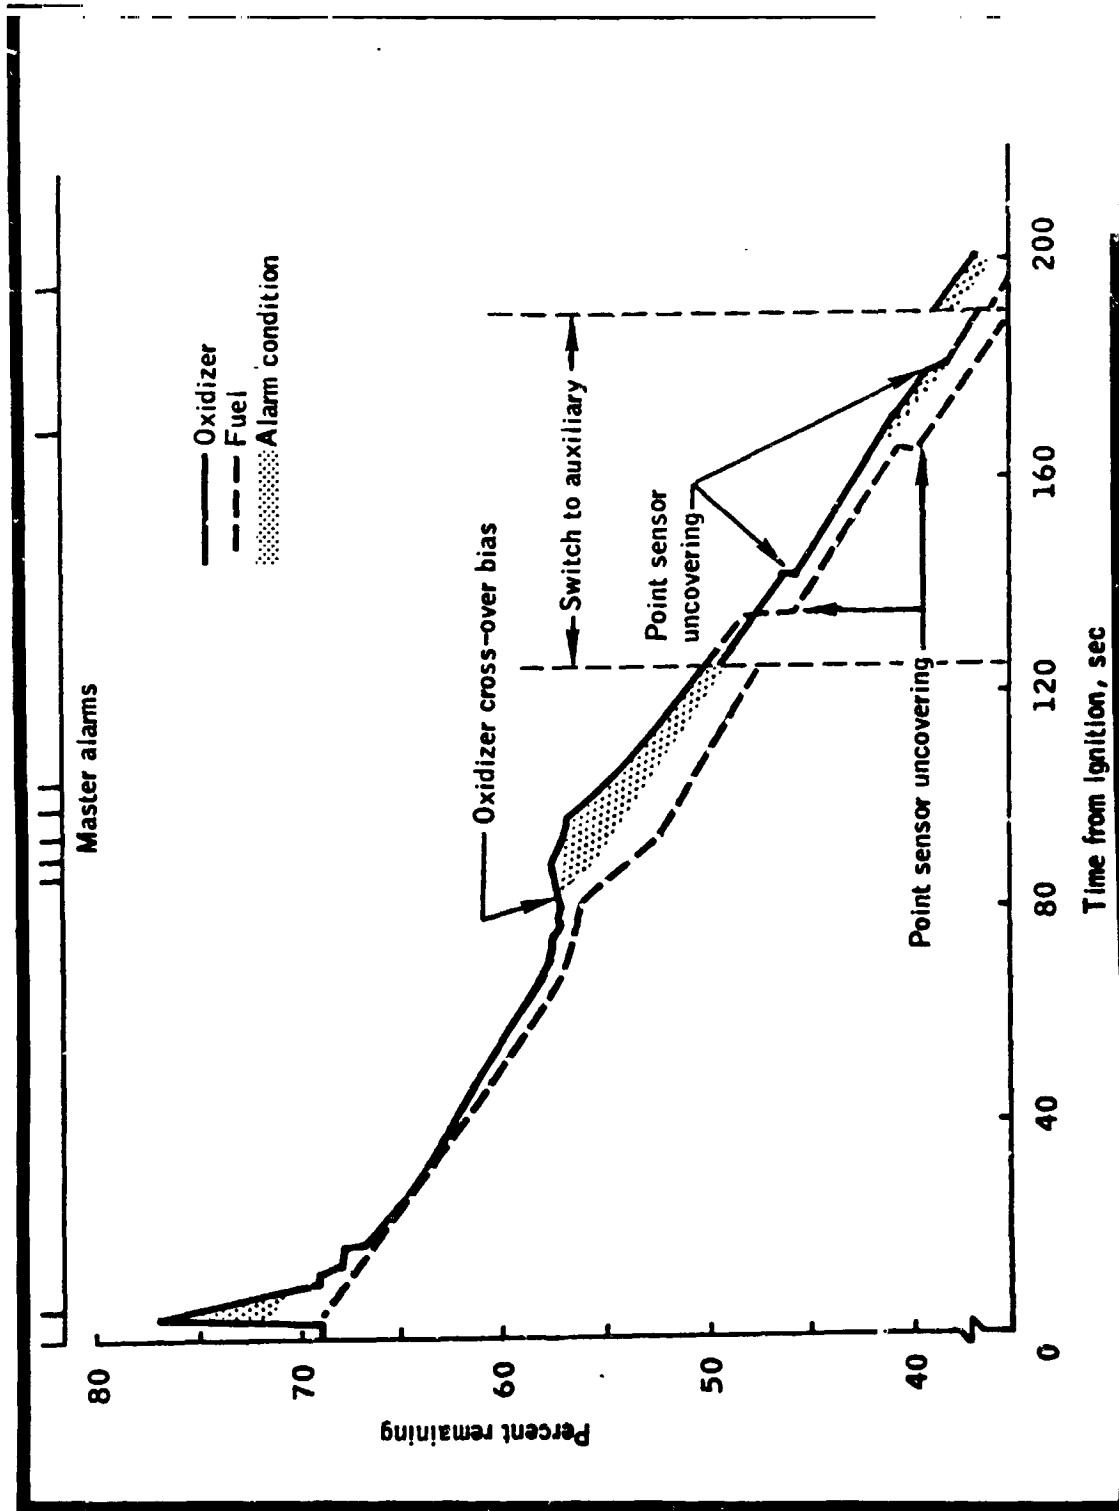
FIG. 2.1.2-1 SERVICE PROPULSION SYSTEM PROPELLANT QUANTITIES

NO. 2.1.2	TITLE: INDICATED SERVICE PROPULSION PROPELLANT UNBALANCE MISSION: APOLLO 9 EVENT TIME: 25:17:40	
SYSTEM: SM		
SUBSYSTEM: SPS		
PROBLEM:	<p>DURING THE THIRD SPS MANEUVER, EIGHT CAUTION AND WARNING INDICATIONS OCCURRED, CAUSED BY AN APPARENT UNBALANCE MEASURED BY THE PROPELLANT UTILIZATION GAUGING SYSTEM (PUGS). HOWEVER, TANK CROSSEOVERS OCCURRED WITHIN LESS THAN ONE SECOND, INDICATING THAT, IN FACT, THE LIQUID LEVELS WERE ESSENTIALLY BALANCED. UNBALANCE AT THE START OF THE BURN IS ASSOCIATED WITH THE TIME REQUIRED TO SETTLE THE GAUGING SYSTEM FROM ZERO TO THE FIRING "G" LEVEL. THE PUGS WAS DISABLED FOR THE FOURTH, FIFTH AND SIXTH SPS MANEUVERS, WHICH WERE OTHERWISE NOMINAL IN ALL RESPECTS.</p> <p>PUGS WAS USED DURING SPS BURN NO. 7 IN ORDER TO GET ENGINEERING DATA ON THE MALFUNCTION. ALL PERFORMANCE PARAMETERS WERE NORMAL DURING THE MANEUVER, EXCEPT FOR THE PUGS READINGS ON THE OXIDIZER STORAGE TANK. RESULTS OF THE TESTS MADE DURING THIS BURN INDICATE THE OXIDIZER QUANTITY WAS BIASED BY ABOUT 3 PERCENT. THIS ERROR HAS BEEN ISOLATED TO THE PRIMARY PROBE IN THE OXIDIZER STORAGE TANK AND WAS CAUSED BY RESIDUAL OXIDIZER CLINGING TO THE PROBE DURING ZERO POINT CALIBRATION.</p>

TITLE: INDICATED SERVICE PROPULSION PROPELLANT UNBALANCE

ACTION:	<p>THE ERRONEOUS BIAS CAUSED BY CLINGING PROPELLANT AND DRYING OF THE DIELECTRIC COMPENSATOR IN THE OXIDIZER STORAGE TANK WILL BE PRECLUDED BY PURPOSELY CALIBRATING THE ZERO POINT OF THE PROBE TO MINUS 0.4 PERCENT. ALTHOUGH THIS MAY RESULT IN A SMALL ERROR WHEN THE TANK CONTAINS OXIDIZER, IT WILL PREVENT ERRORS ON THE ORDER OF 1.9 TO 3.0 PERCENT, AS OBSERVED ON THIS FLIGHT. THIS MODIFICATION WILL BE TESTED AT WHITE SANDS BEFORE IT IS INCORPORATED. PROCEDURES HAVE BEEN CHANGED FOR THE CREW TO IGNORE THE UNBALANCE DURING THE FIRST 25 SECONDS OF A FIRING TO ALLOW SUFFICIENT TIME FOR PROPELLANT SETTling. MASTER ALARM AND CAUTION AND WARNING INDICATIONS FROM THE "PUGS" ARE NOT REQUIRED AND THESE FUNCTIONS HAVE BEEN ELIMINATED FROM SPACECRAFT 106 AND SUBSEQUENT.</p>	
ORGANIZATION: REFERENCES:	RESOLUTION: CLOSED DATE: 6-13-69 REV:	
	5-2490 MSC 5-DAY REPORT, P. 10 FINAL FLIGHT REPORT, 3-13-69 MSC 30-DAY ANOMALY REPORT P. 5 MSC 60-DAY REPORT-PA-R-69-2, P.17.7

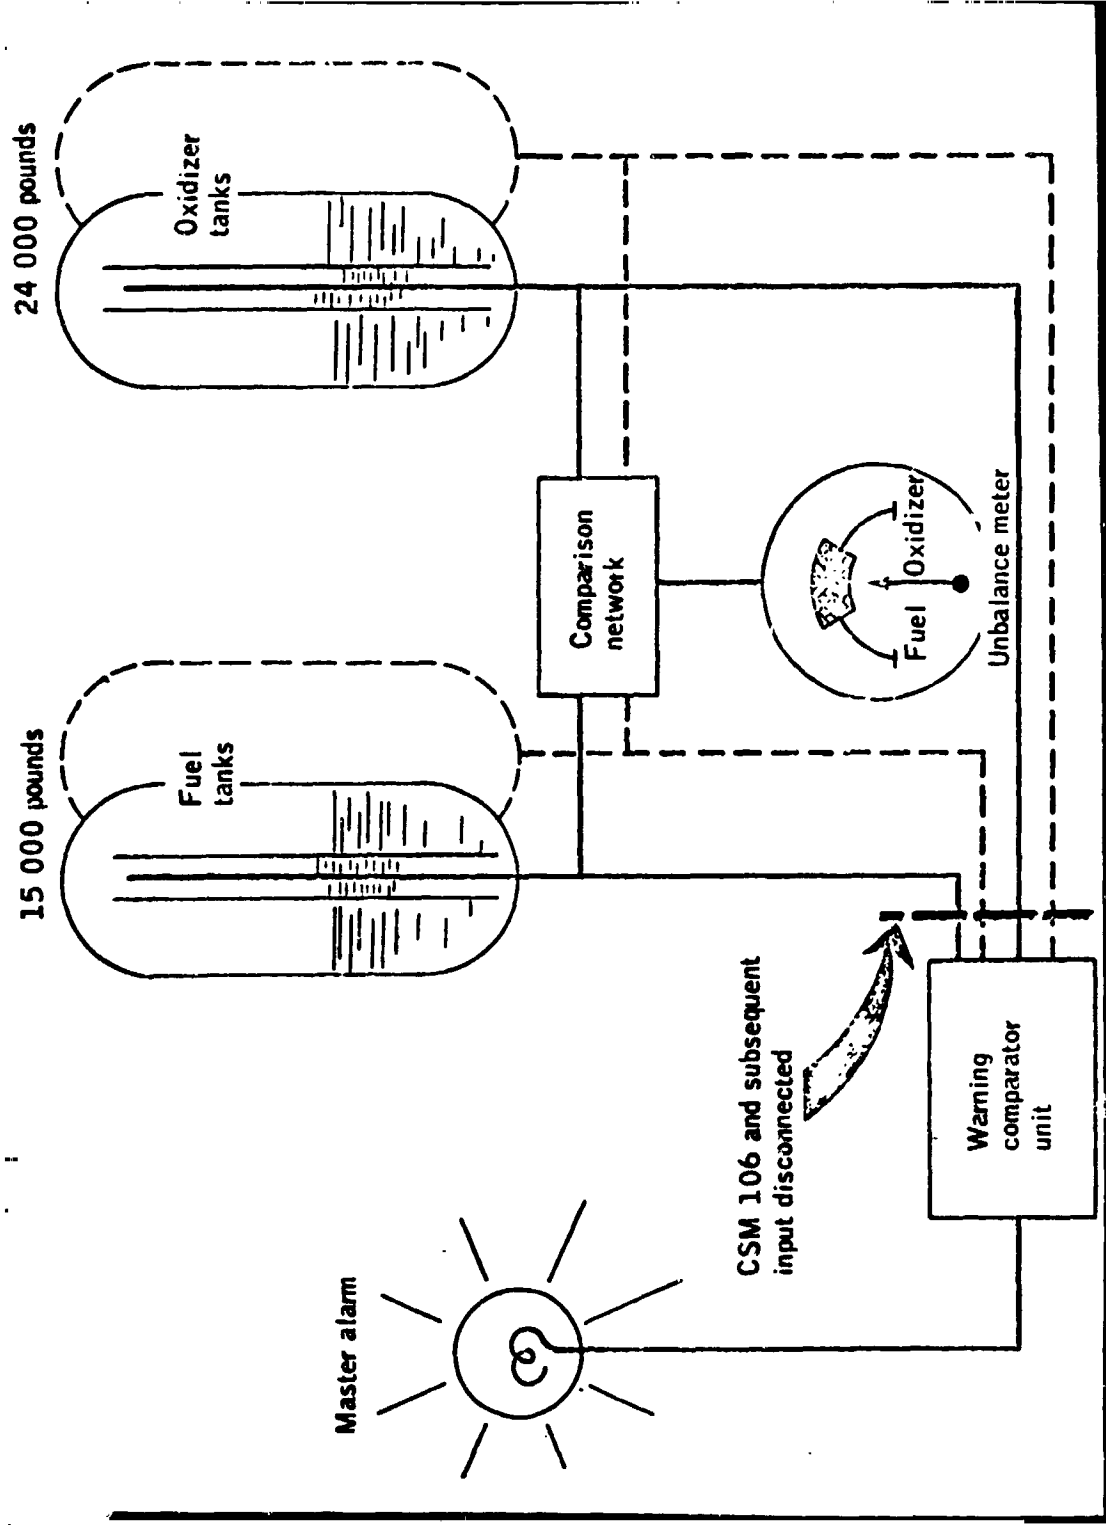
FIG. 2.1.2-2 PRIMARY PROPELLANT UTILIZATION SYSTEM CIRCUIT

TITLE: INDICATED SERVICE PROPULSION PROPELLANT UNBALANCE

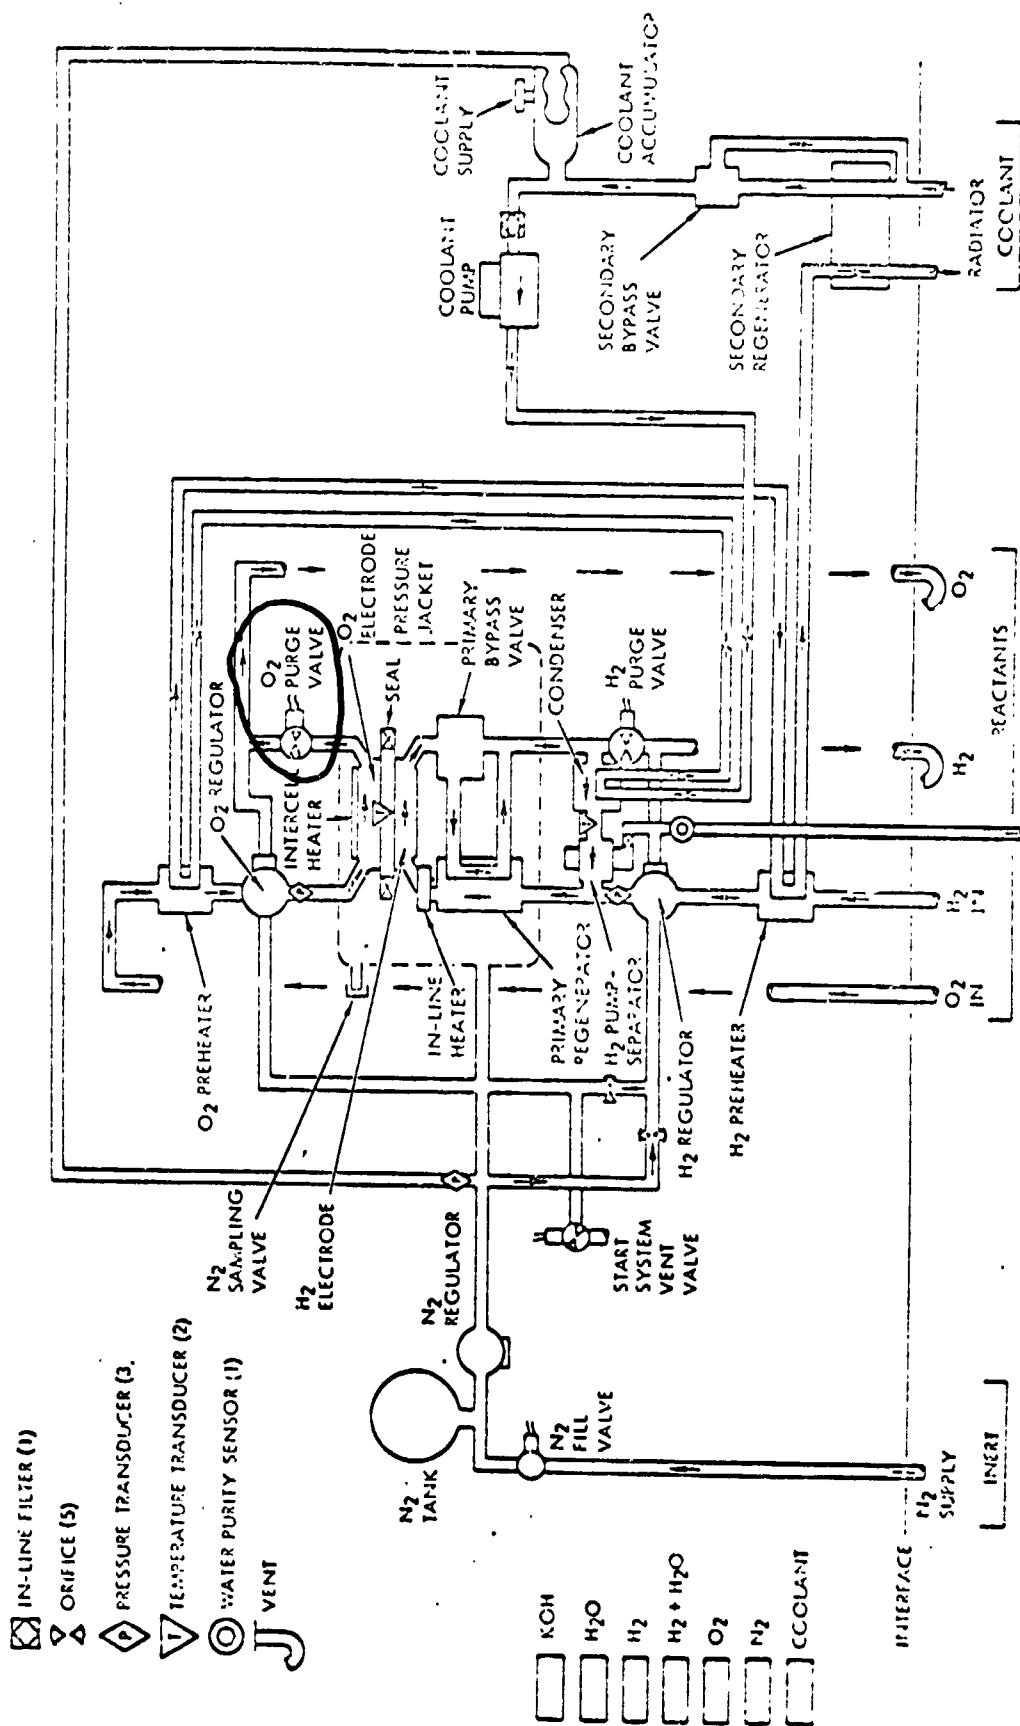
FIG. 2.1.3-1 FUEL CELL NO. 3 DIAGRAM

NO. 2.1.1.3	TITLE: HIGH O ₂ FLOW RATE ON FUEL CELL NO. 3	MISSION: APOLLO 9
SYSTEM: CSM		EVENT TIME: 25:18
SUBSYSTEM: ELECTRIC POWER		
<p>PROBLEM: AT 25:26 GET, AFTER SPS BURN NO. 3, THE OXYGEN FLOW RATE TO FUEL CELL NO. 3 WAS HIGH, 0.78 LB/HR. THE INCREASE WAS NOT COMPATIBLE WITH THE INDICATED HYDROGEN FLOW RATE OF 0.072 LB/HR. AT APPROXIMATELY 26:10, FUEL CELL NO. 3 WAS PURGED, AND AT 27:45 THE O₂ FLOW RATE RETURNED TO NORMAL.</p> <p>INDICATIONS ARE THAT FLOW WAS NORMAL TO THE FUEL CELL AND THAT THE FLOW METER WAS ERRATIC; FLOW DATA RETURNED TO NORMAL AT 28:00.</p>		
ACTION:		
ORGANIZATION: 5-2490	RESOLUTION: CLOSED	DATE: 6-13-69
REFERENCES: MSC 5-DAY REPORT, P. 8		REV:
		29

TITLE: HIGH O₂ FLOW RATE ON FUEL CELL NO. 3.

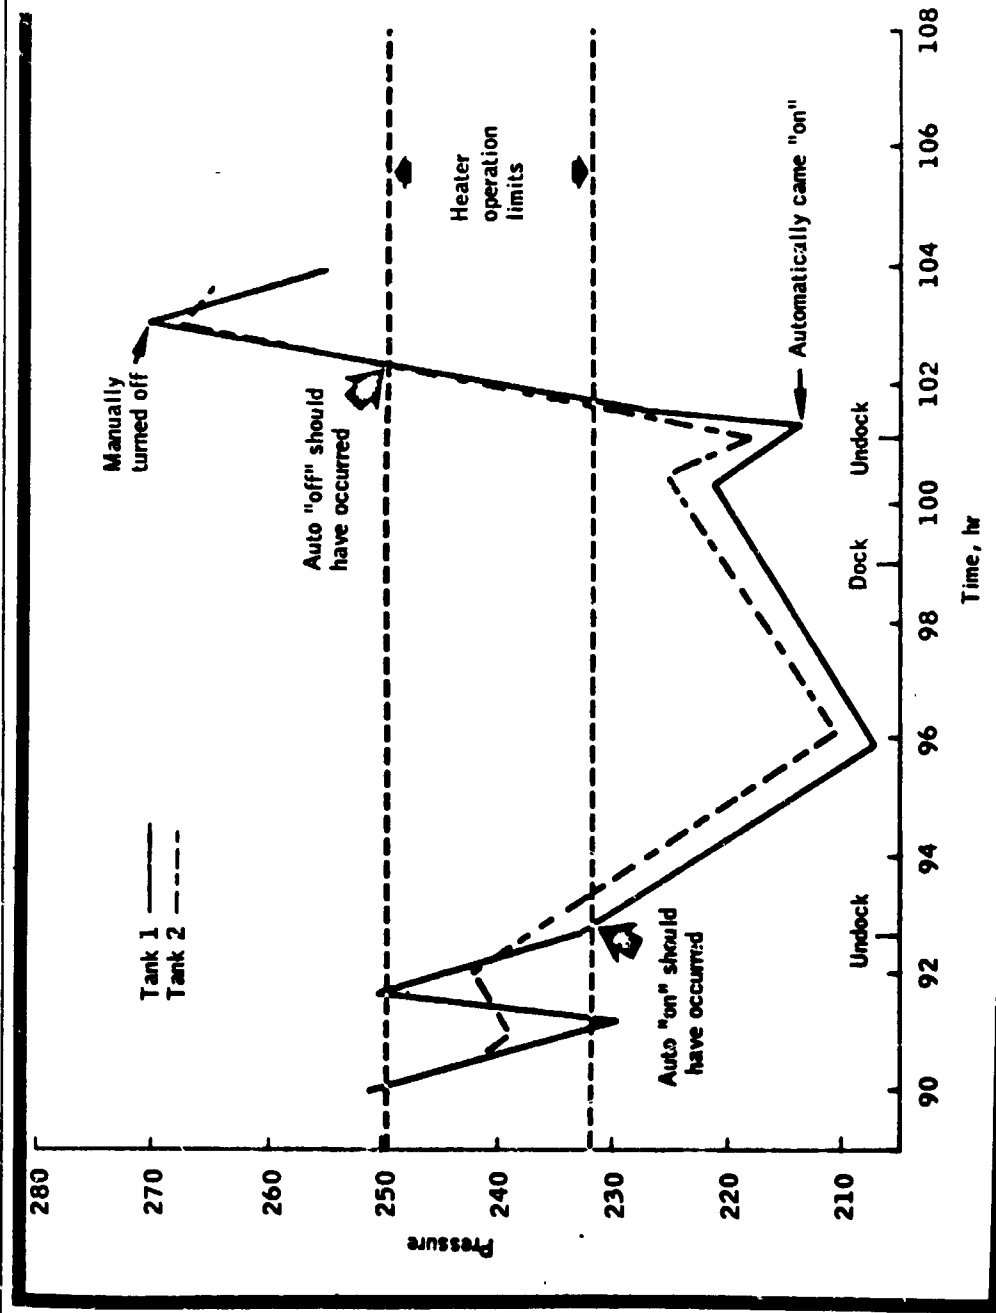
FIG. 2.1.5-1 HYDROGEN TANK PRESSURE-HEATER OPERATION

NO. 2.1. 5	TITLE: LOSS OF AUTOMATIC CRYOGENIC HYDROGEN PRESSURE CONTROL	MISSION: APOLLO 9
SYSTEM: CSM		EVENT TIME: 93:00
SUBSYSTEM: EPS (FUEL CELLS)	<p>PROBLEM: AT 93 HOURS, LH₂ TANK HEATERS FAILED TO COME ON AUTOMATICALLY. AT 101 HOURS, AUTO SYSTEM RECOVERED AND INCREASED PRESSURE BEYOND AUTO CUTOFF SETTING (270°F). HEATING SYSTEM WAS MANUALLY TURNED OFF AT 106 HOURS. PRESSURE CONTROL WAS MAINTAINED BY MANUAL FAN CONTROL FOR REMAINDER OF MISSION.</p> <p>SINCE THE FIRST FAILURE (FAILURE TO TURN ON) WOULD HAVE REQUIRED ONE PRESSURE SWITCH TO FAIL OPEN AND THE SECOND FAILURE (FAILURE TO TURN OFF) WOULD HAVE REQUIRED THAT BOTH PRESSURE SWITCHES FAIL CLOSED, THE SWITCHES CAN BE RULED OUT. THE MOST PROBABLE CAUSE FOR THE FAILURES WAS AN INTERMITTENT CONDITION IN THE MOTOR OR ITS CONTROL CIRCUIT (INCLUDING THE POWER LINE, GROUND, AND THE TERMINAL BOARD FOR 16-GAGE PINS) RESULTING FROM THE UNDOCKING SHOCK (SEE FIG. 5). SIXTEEN-GAGE TERMINAL BOARDS HAVE BEEN THE SOURCE OF INTERMITTENT CONTACT PROBLEMS DURING VEHICLE GROUND TESTS.</p> <p>ACTION: NO CORRECTIVE ACTION WILL BE TAKEN FOR APOLLO 10; THE TANK PRESSURES CAN BE CONTROLLED MANUALLY BE EITHER THE HEATERS OR THE FANS IF THE AUTOMATIC SYSTEM FAILS.</p>

TITLE: LOSS OF AUTOMATIC CRYOGENIC HYDROGEN PRESSURE CONTROL

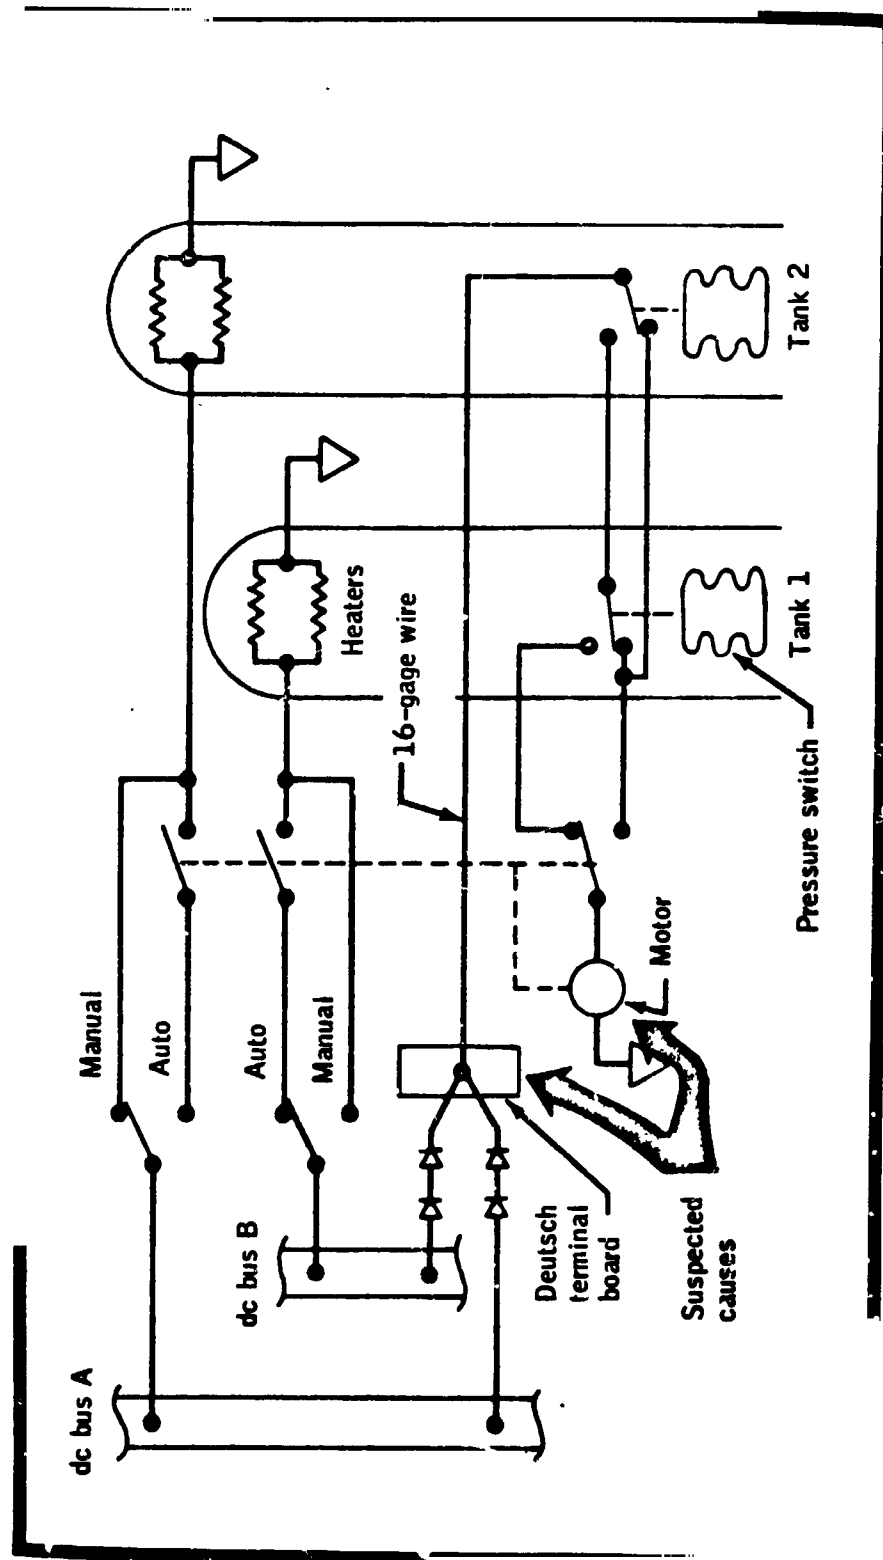
FIG. 2.1.5-2 HYDROGEN TANK PRESSURE CONTROL

TITLE: LOSS OF AUTOMATIC CRYOGENIC HYDROGEN PRESSURE CONTROL

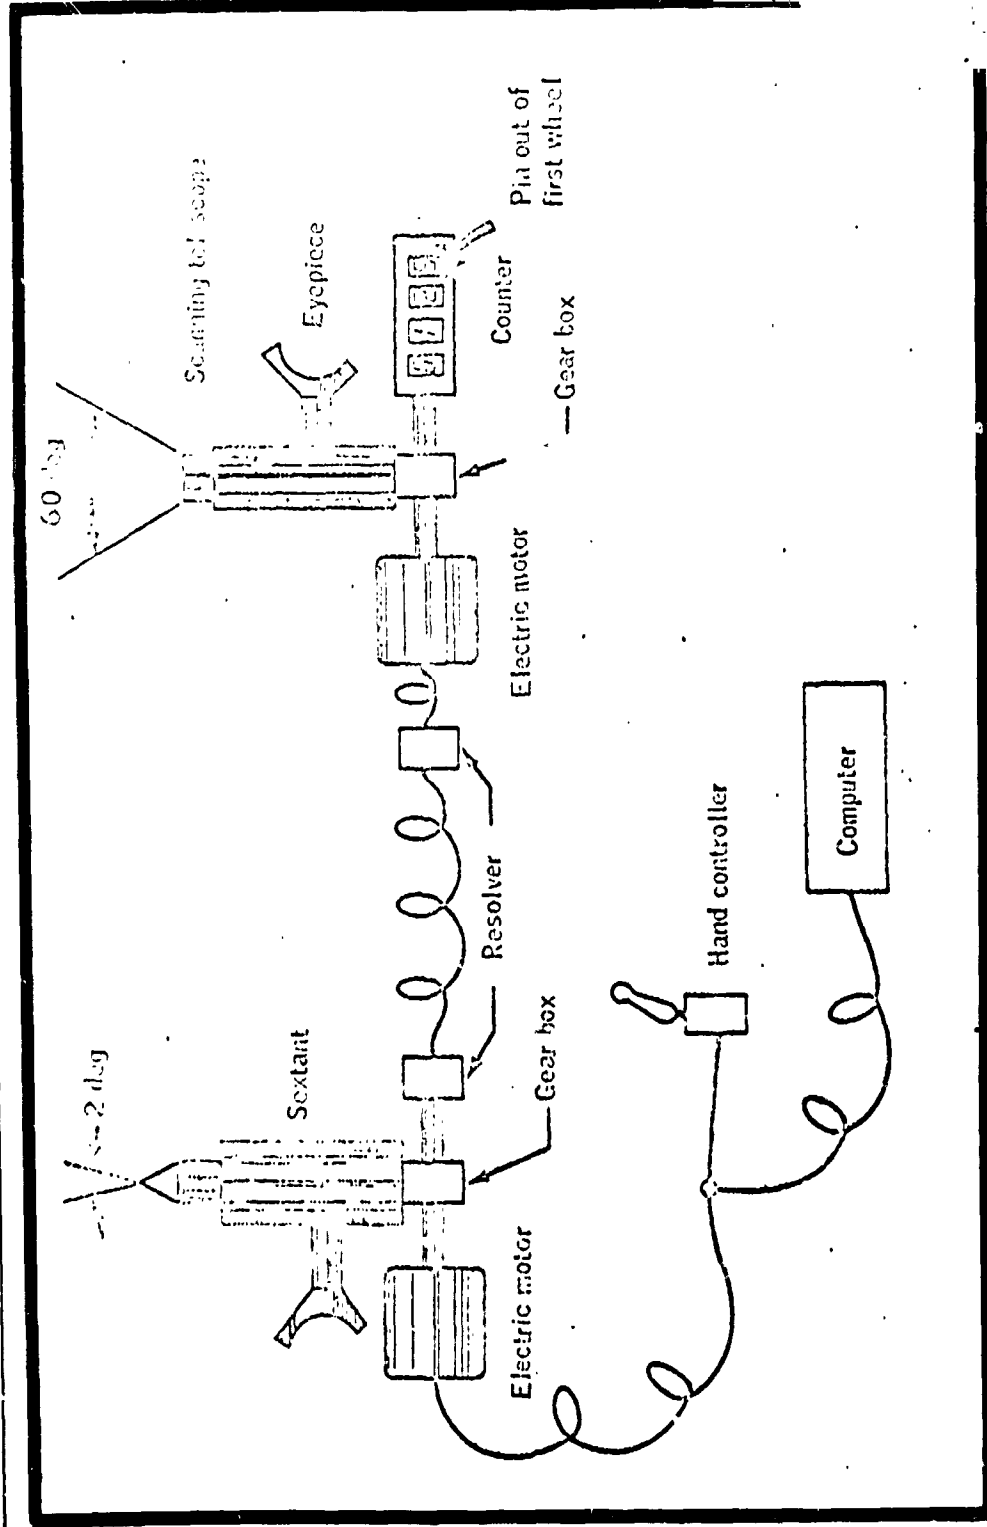
FIG. 2.1.11-1 SCANNING TELESCOPE CIRCUIT

TITLE: SCANNING TELESCOPE DRIVE SHAFT PROBLEM

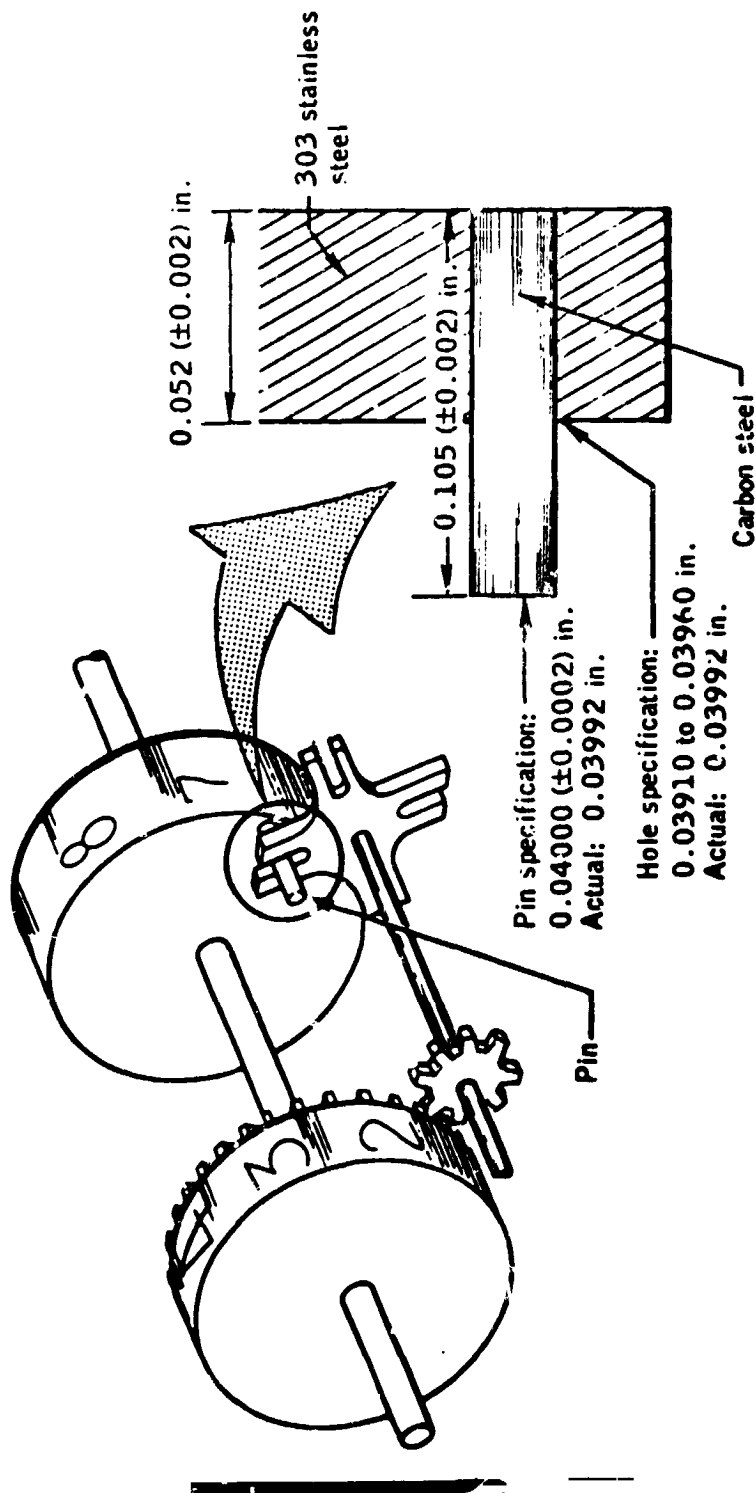
FIG. 2.1.11-2 SCANNING TELESCOPE - COUNTER SHAFT

TITLE: SCANNING TELESCOPE SHAFT DRIVE PROBLEM

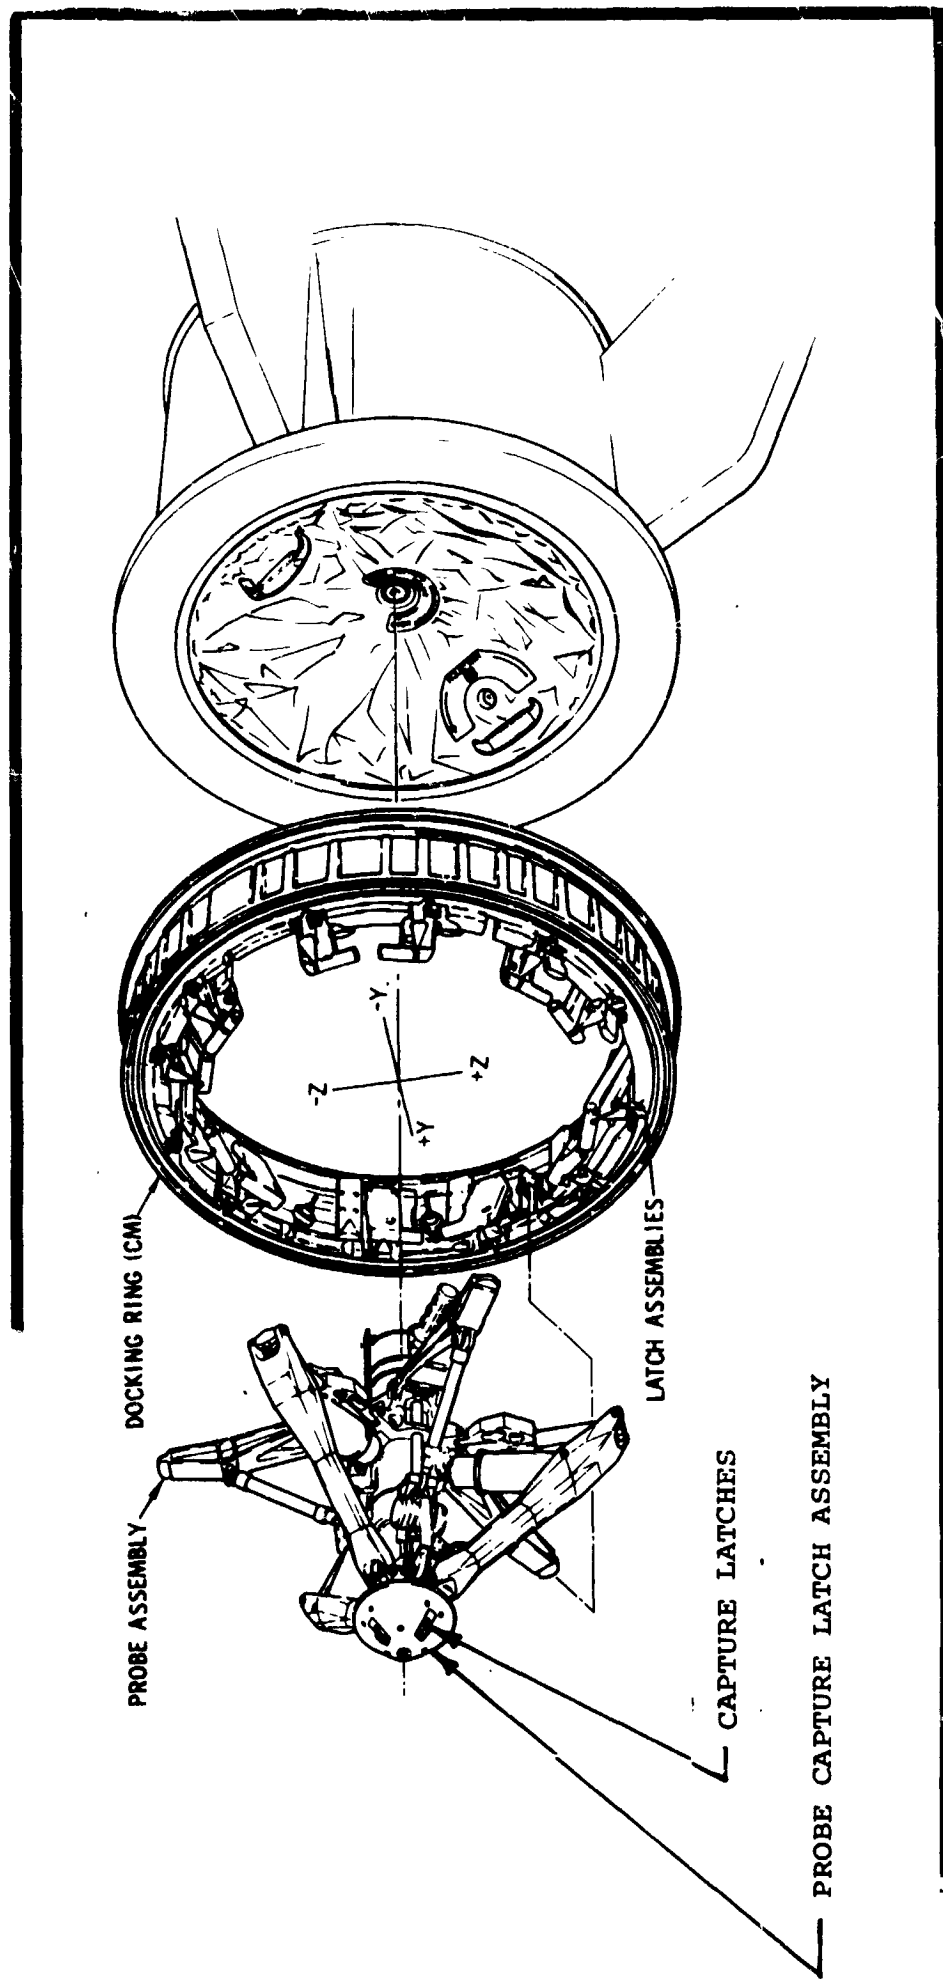
FIG. 2.1.12-1 DOCKING PROBE

TITLE: ERRONEOUS DOCKING PROBE INDICATIONS

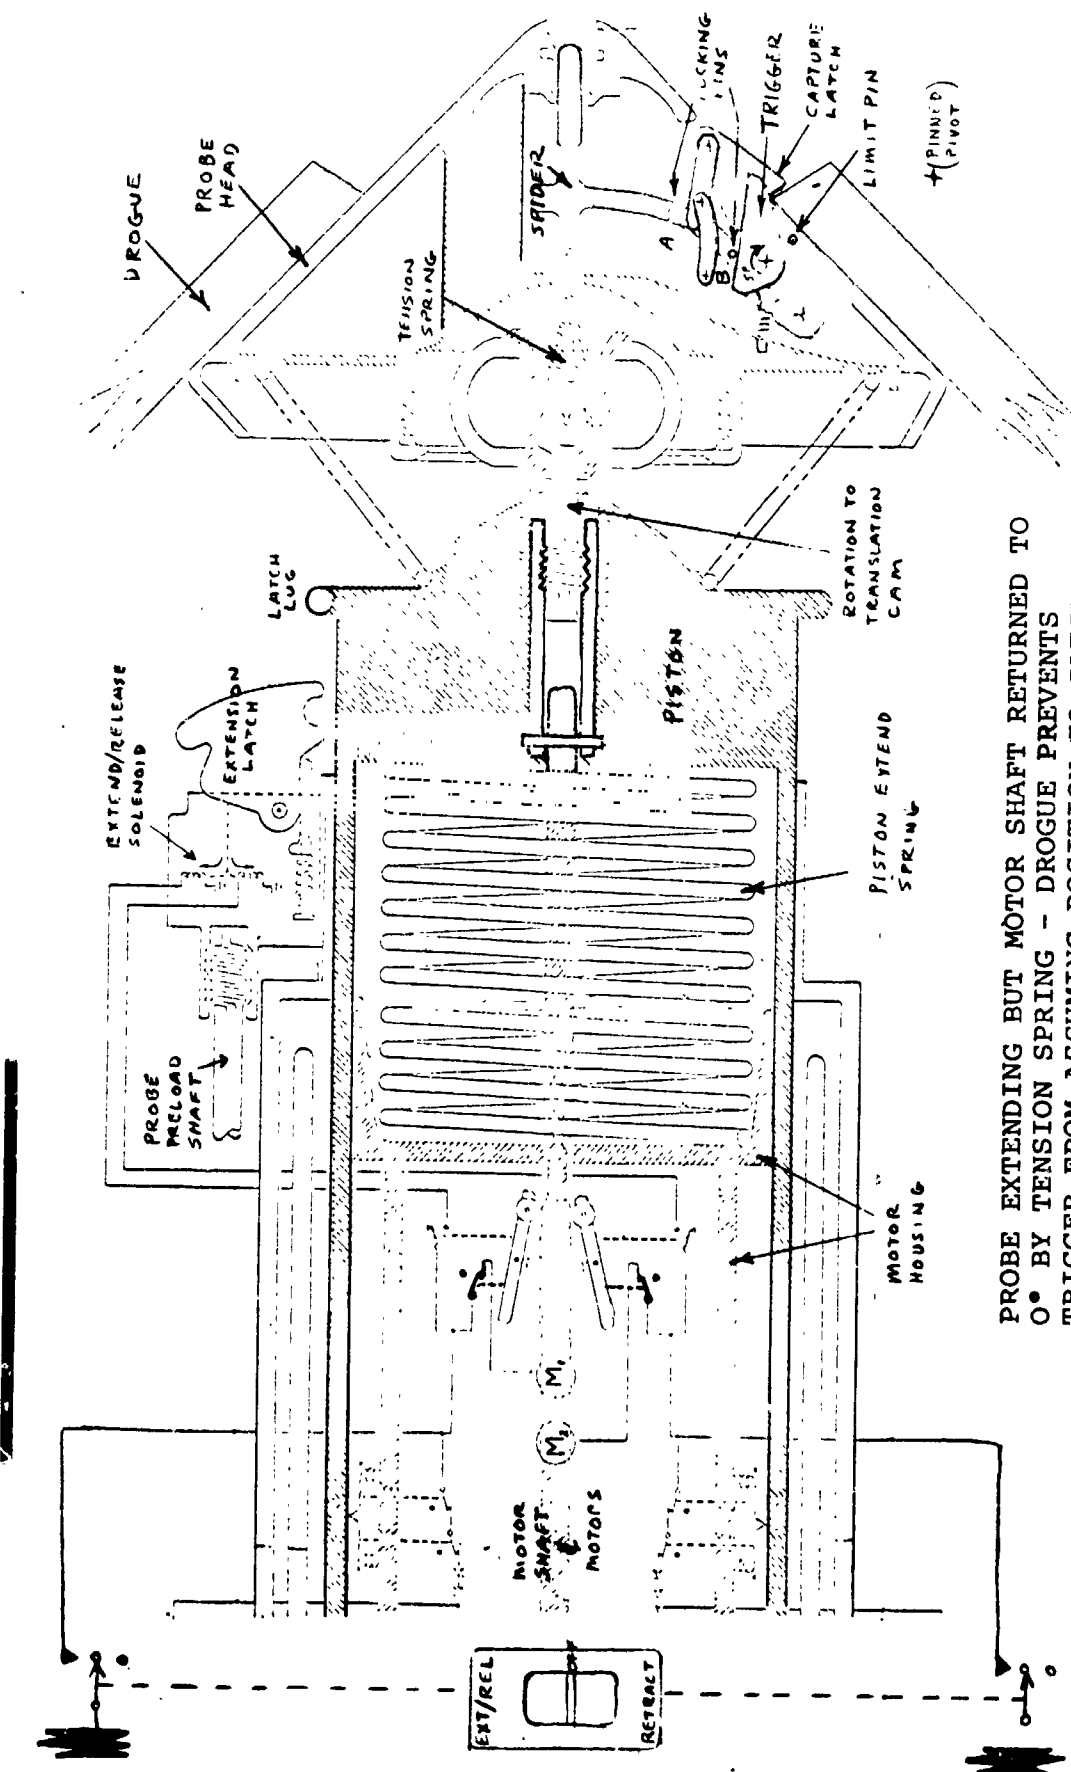
TITLE: DOCKING PROBE DETAILS FIG. 2.1.12-2

PROBE EXTENDING BUT MOTOR SHAFT RETURNED TO 0° BY TENSION SPRING - DROGUE PREVENTS TRIGGER FROM ASSUMING POSITION TO CATCH LOCK PIN ON SPIDER-THEREFORE, ROLLING LOCKING PIN ON SPIDER HAS RETURNED TO THE CAPTURE-LATCH LOCK POSITION.

SPIDER IN UN-LOCKED POSITION

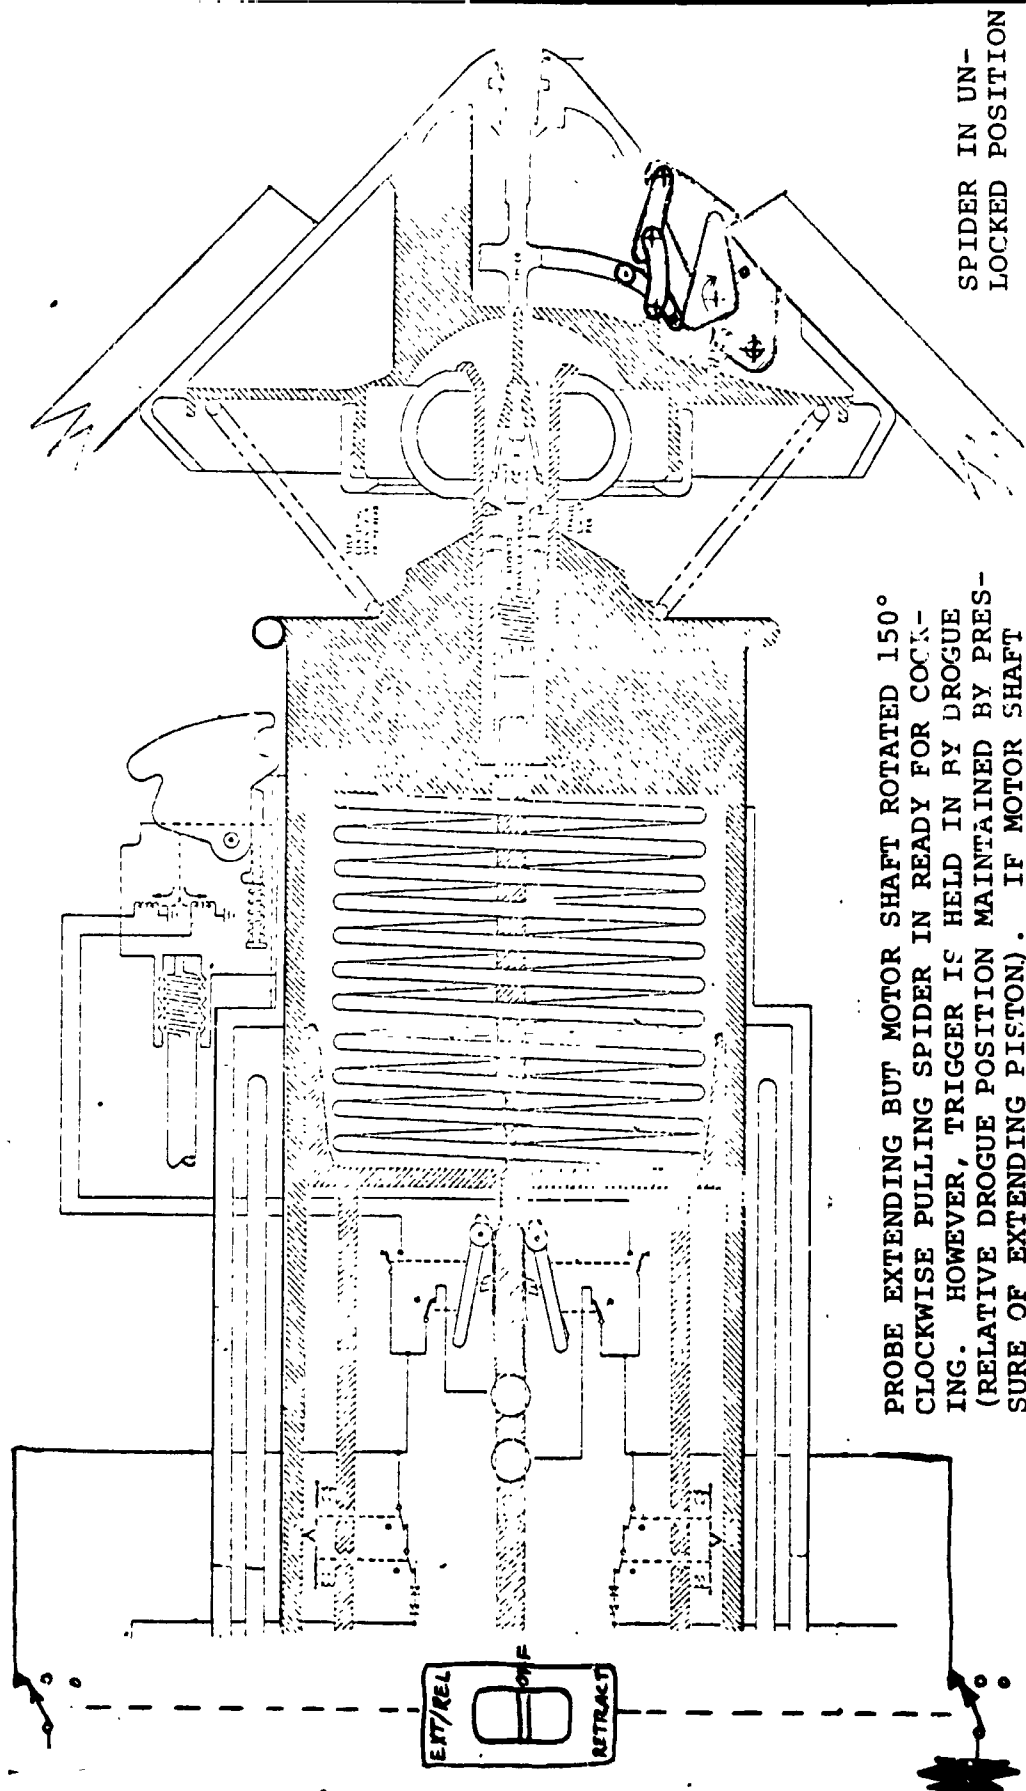
FIG. 2.1.12-3

PROBE EXTENDING BUT MOTOR SHAFT ROTATED 150° CLOCKWISE PULLING SPIDER IN READY FOR COCKING. HOWEVER, TRIGGER IS HELD IN BY DROGUE (RELATIVE DROGUE POSITION MAINTAINED BY PRESURE OF EXTENDING PISTON). IF MOTOR SHAFT IS IN 150° POSITION AT END OF PISTON TRAVEL (10 INCHES), SPACECRAFT WILL UNDOCK. 150° POSITION CAN ONLY BE MAINTAINED AS LONG AS MOMENTARY SWITCH SUPPLIES POWER TO MOTORS, OR IF TRIGGER CAN FREELY SWING BACK TO LIMIT PIN AND CATCH THE SPIDER.

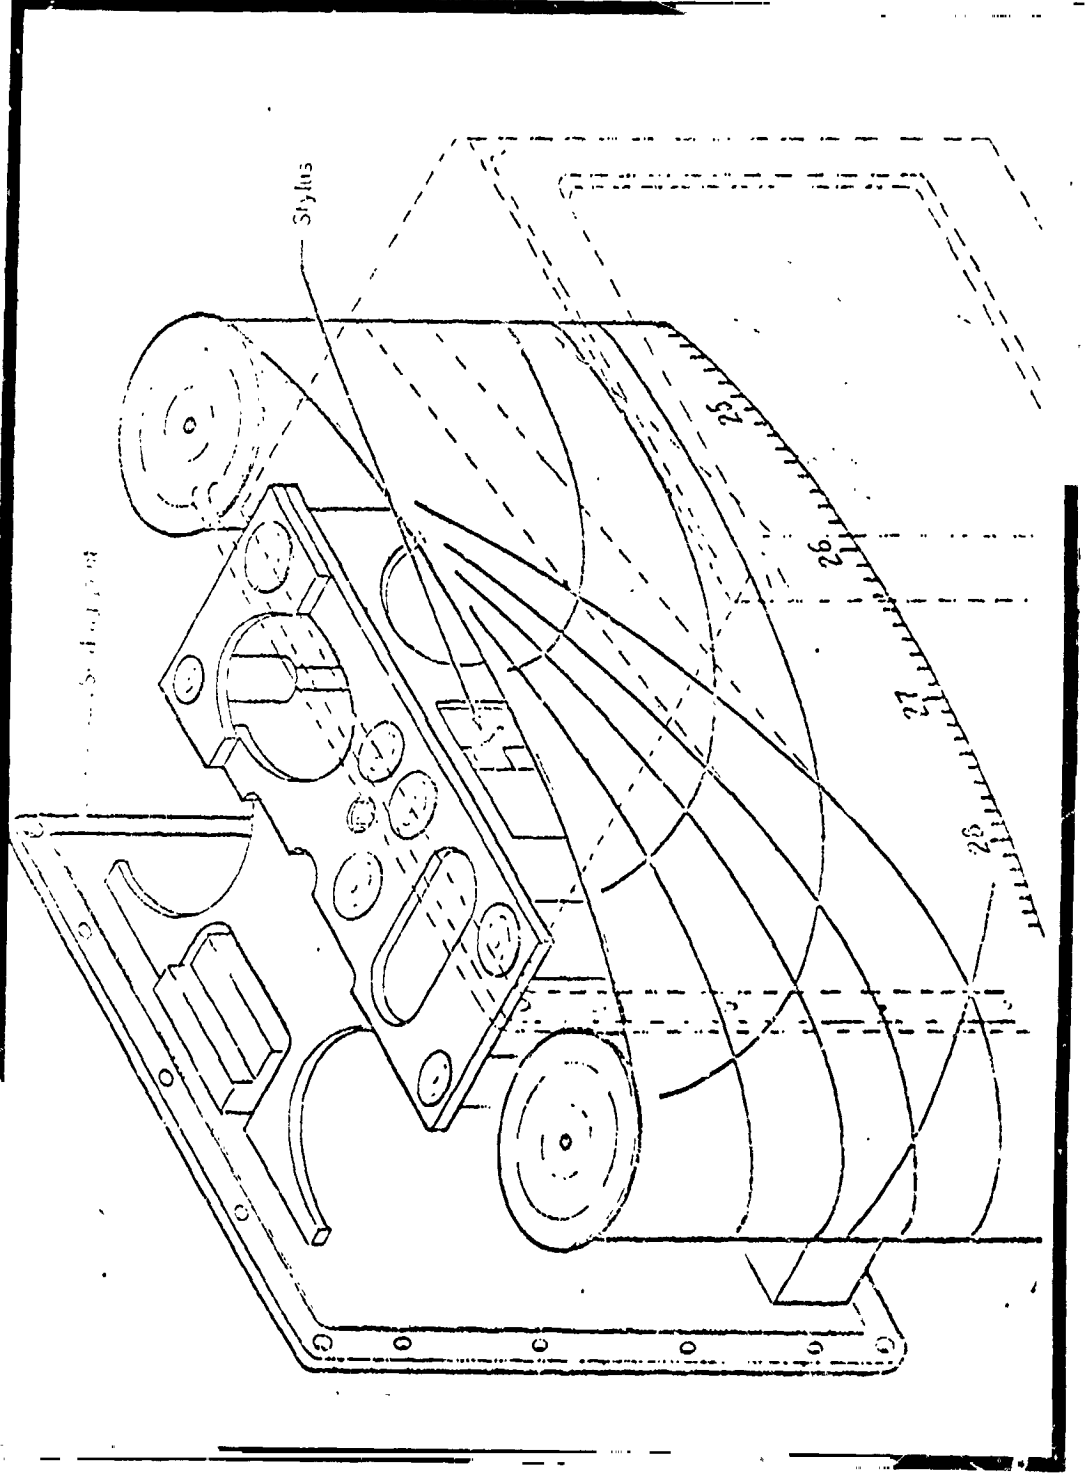
FIG. 2.1.16-1 ENTRY MONITOR

<p>NO. 2.1.1.16</p> <p>SYSTEM: CSM</p> <p>SUBSYSTEM: EMS</p>	<p>TITLE: ENTRY MONITOR SYSTEM (EMS) FAILURE</p> <p>MISSION: APOLLO 9</p> <p>EVENT TIME: ENTRY</p> <p>PROBLEM: DURING THE ENTRY ON APOLLO 9 MISSION, EMS SCRIBE FAILED.</p> <p>ACTION: THE ENTRY MONITOR SYSTEM STYLUS DID NOT CONTINUOUSLY CUT THROUGH THE EMULSION ON THE SCROLL ASSEMBLY. THE ACCELEROMETER OUTPUT OF THE ENTRY MONITOR DRIVES THE STYLUS TO SCRIBE THE ACCELERATION (G) HISTORY.</p> <p>DURING MANUFACTURING, THE SCROLL ASSEMBLY IS PRESSURIZED TO ONE ATMOSPHERE WITH AN INERT GAS TO PREVENT THE FILM EMULSION FROM HARDENING. DURING THE POSTFLIGHT TESTING, A LEAK WAS DETECTED IN THE SCROLL ASSEMBLY, AND IT WAS CONFIRMED THAT THE INERT GAS HAD BECOME DILUTED. FURTHER TESTING REVEALED THAT THE STYLUS TENDED TO EXTEND SLOWLY, APPARENTLY BECAUSE OF FRICTIONAL INTERFERENCE. EXAMINATION OF THE SCROLL REVEALED THAT THE STYLUS HAD TRACED ON THE EMULSION DURING ENTRY BUT WITH INADEQUATE FORCE FOR COMPLETE PENETRATION. BECAUSE OF THE LEAK, THE FILM EMULSION WAS SUBJECTED TO A SLOW VACUUM DRYING DURING THE MISSION, AND IT BECAME HARD. A LEAK-TESTED SCROLL ASSEMBLY, WITH A FINER STYLUS POINT WHICH WILL PENETRATE HARDER EMULSIONS, AND SEVERAL OTHER NOR MODIFICATIONS WILL BE INSTALLED ON APOLLO 10.</p> <p>POST-FLIGHT TESTING OF THE SCROLL ASSEMBLY REVEALED A LEAK AROUND THE BASE OF AN ADJUSTMENT SCREW CUP. CONTAMINATION ON THE STYLUS HOLDER AND BUSHING, CAUSED BY "LOCK-TITE" USED ON THE KEEPER SCREW OF THE STYLUS HOLDER, CAUSED A 2-3 SECOND LAG IN STYLUS RESPONSE. GLYPTOL WILL BE USED ON FUTURE FLIGHTS.</p>

TITLE: ENTRY MONITOR SYSTEM FAILURE

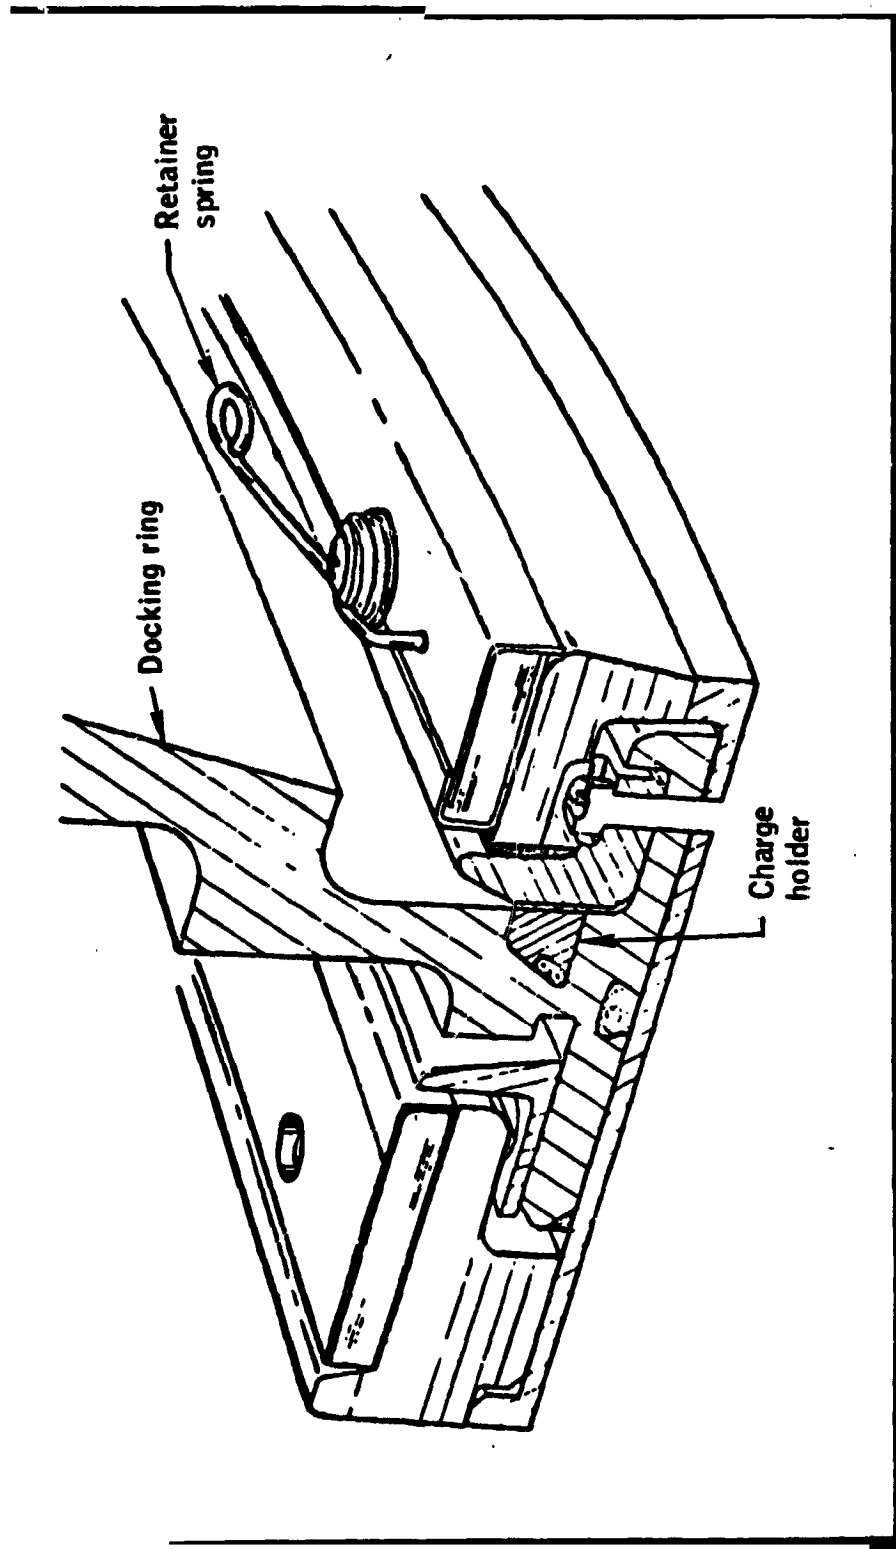
FIG. 2.1.21-1 DOCKING RING CHARGE HOLDER

TITLE: DOCKING RING SEPARATION CHARGE HOLDER
